DENTAVANTGART

ON/OFF

DR. SERGEY GRISHIN

THE PROBLEM OF EXCESS RESTORATIVE MATERIAL ON TOOTH SURFACE

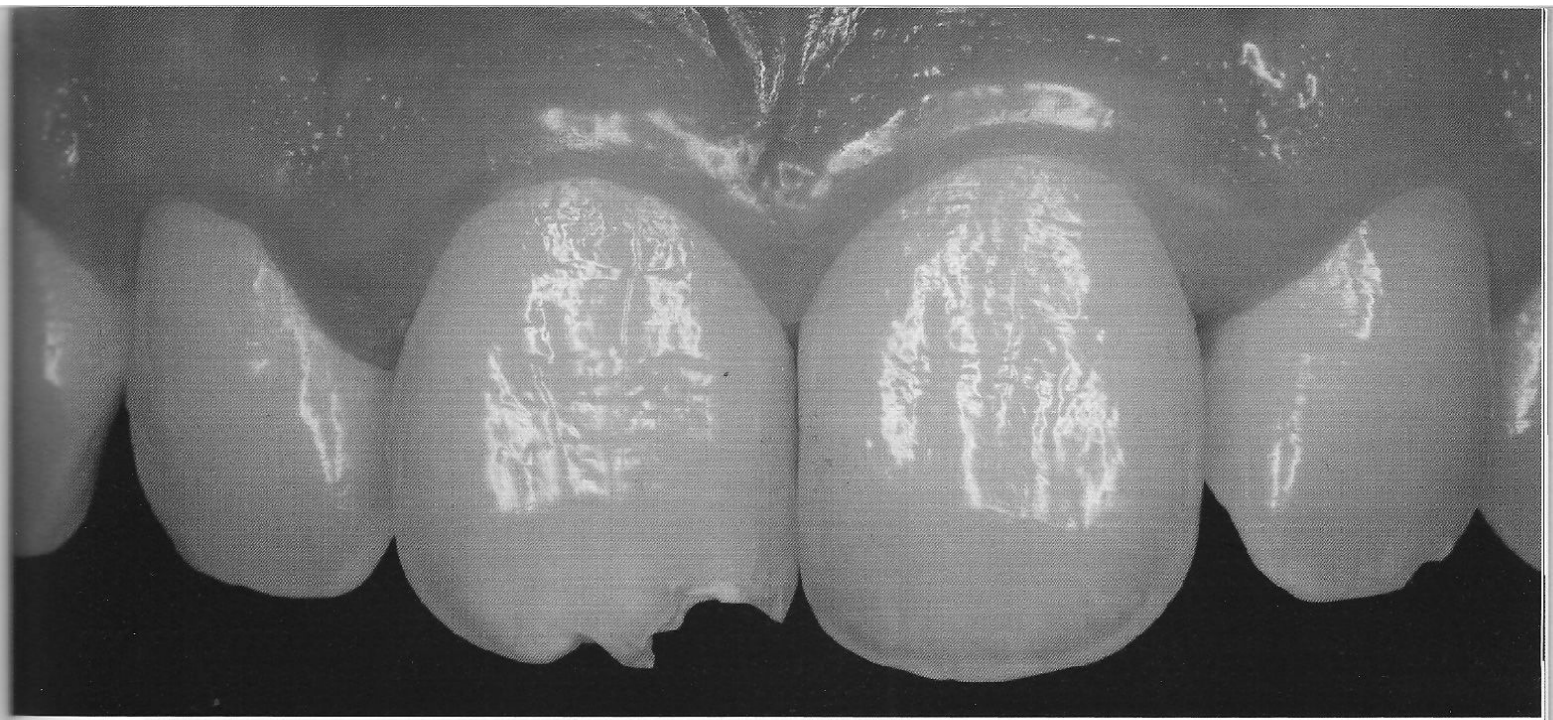
1 I was consulted by a 28-year-old male patient with defective cutting edges in tooth no. 11 following an injury

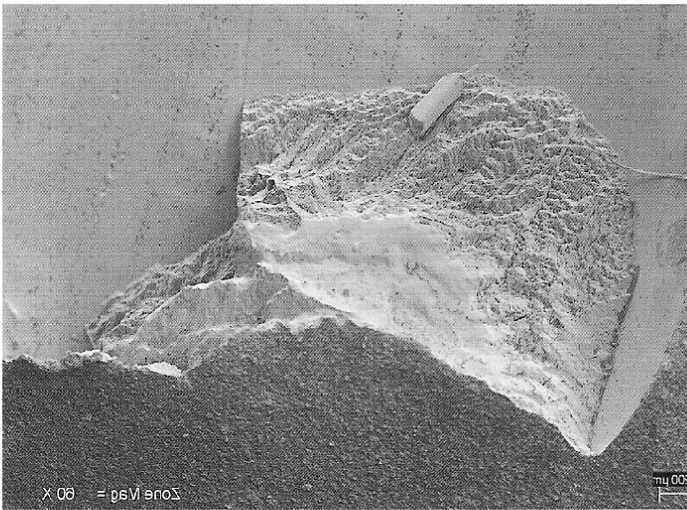
2 SEM* of the cutting edge defect in tooth no. 11

After making the diagnosis, I decided to prepare a non-invasive direct restoration. I chose this technique because of the shape and size of the defect and the tissue condition (**Fig. 2, 3**).

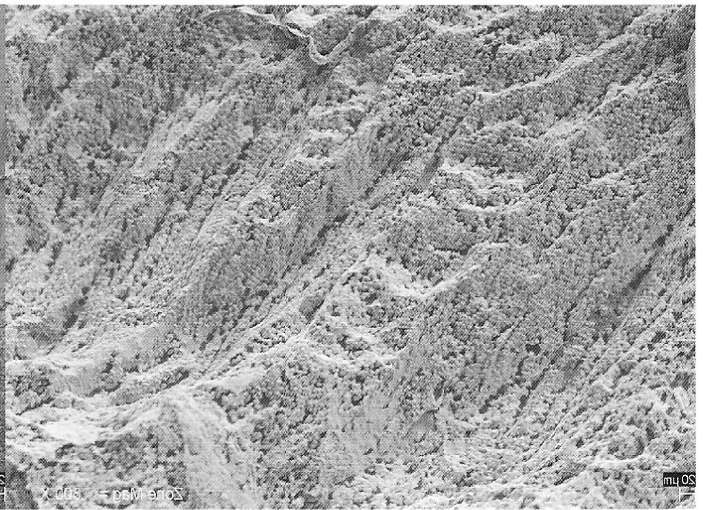
3 SEM of the cutting edge defect in the enamel of tooth no. 11

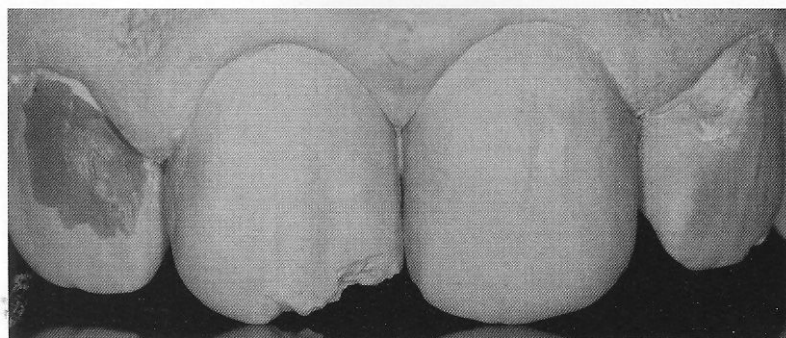
4
The casts

During the patient's first visit I took teeth imprints and made dental casts (**Fig.4**).

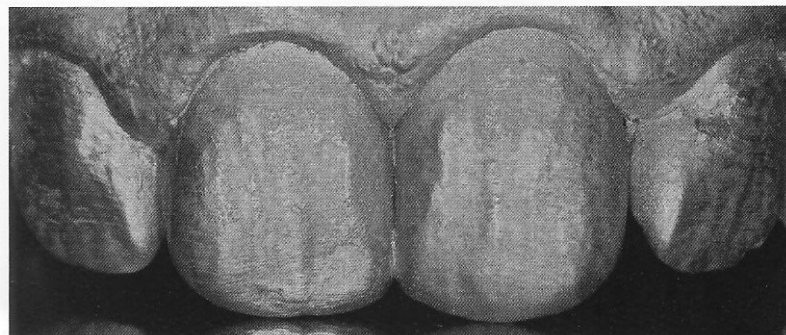
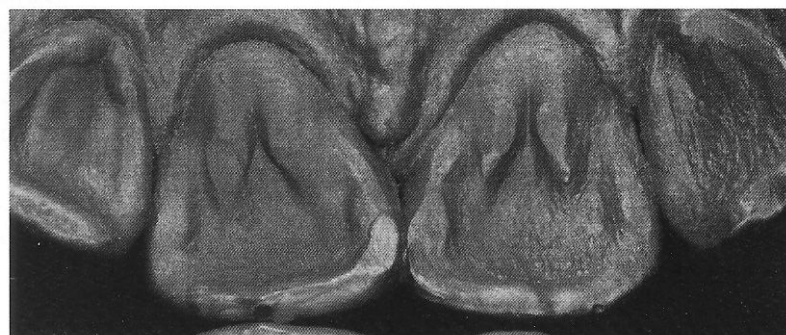
5-6
Wax-Up

Then I prepared silicone keys from the Wax-Up (**Fig. 5, 6**).

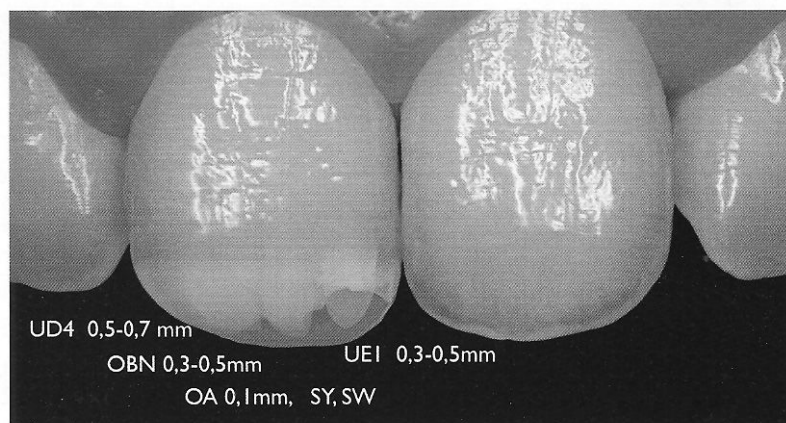
7
Colour chart

During the planning stage I created a detailed colour scheme for restoration with a 3D-tissue map (**Fig. 7, 8**).

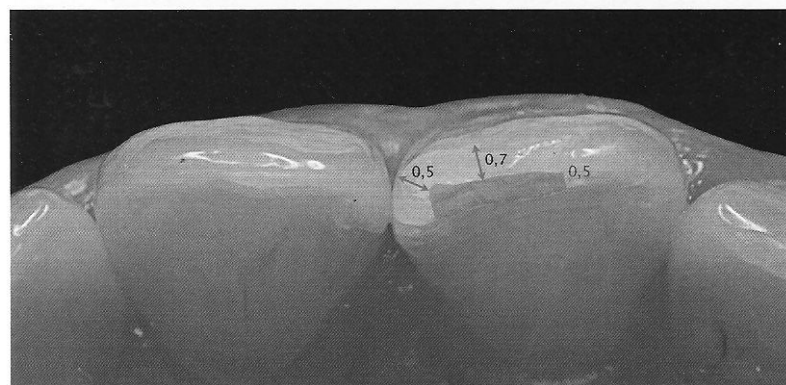
8.
The amount of tissue lost

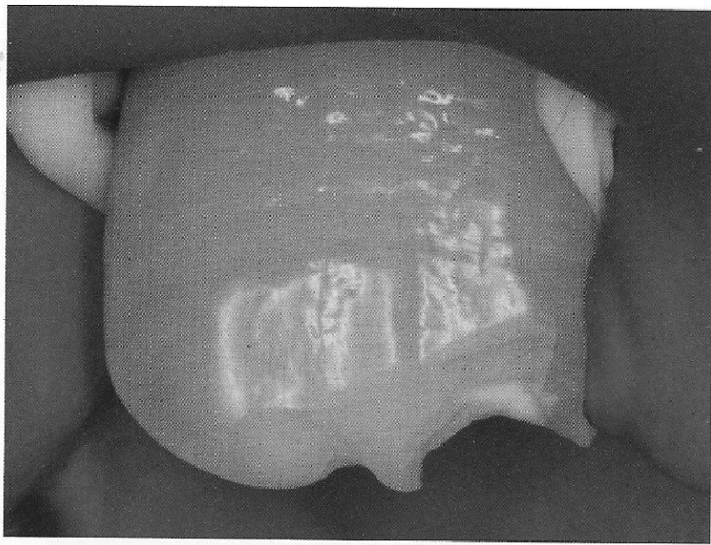
9
Photo of the defect
after sandblasting

As the restoration would have enough retention due to the shape and location of the defect, I chose non-invasive technique. The defective surface of the cutting edge of tooth no. 11 was treated using a sand blaster with 27-micron grade aluminium oxide powder (**Fig. 9, 10, 11**).

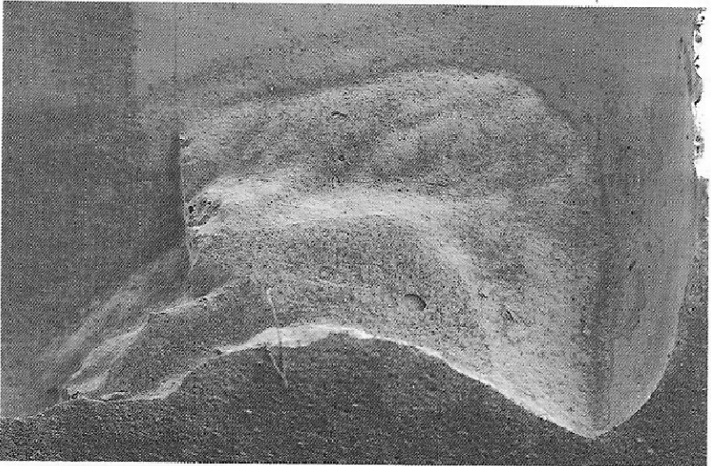
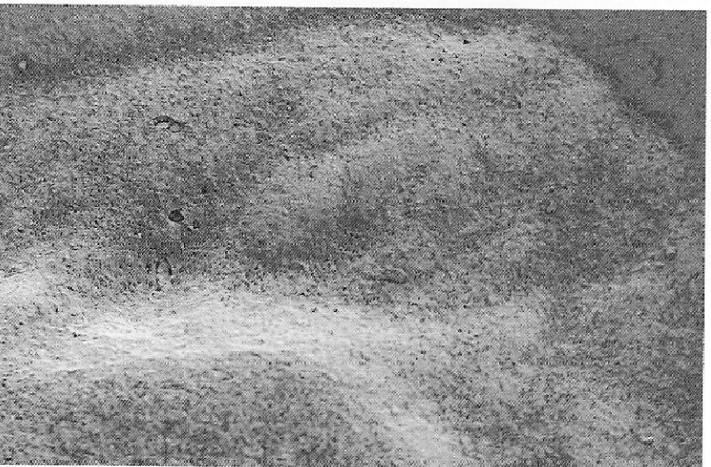
10, 11
SEM of the defect
after sandblasting

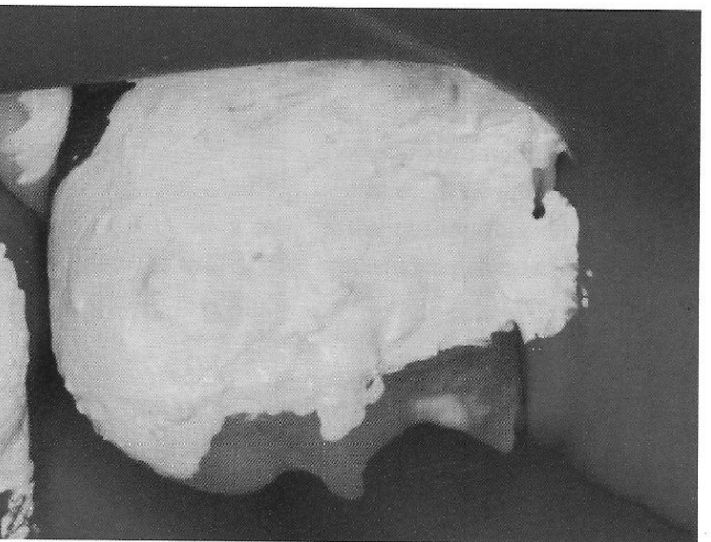
12
Vestibular surface
of the teeth with a
protective layer

Then I covered the vestibular surface of the teeth with a protective layer (**Fig. 12**). As I have already mentioned, I used correction fluid as a protector. I removed a portion of the protective layer in the demarcation area for a better match of composite material and tooth tissues and greater control over the protective layer.

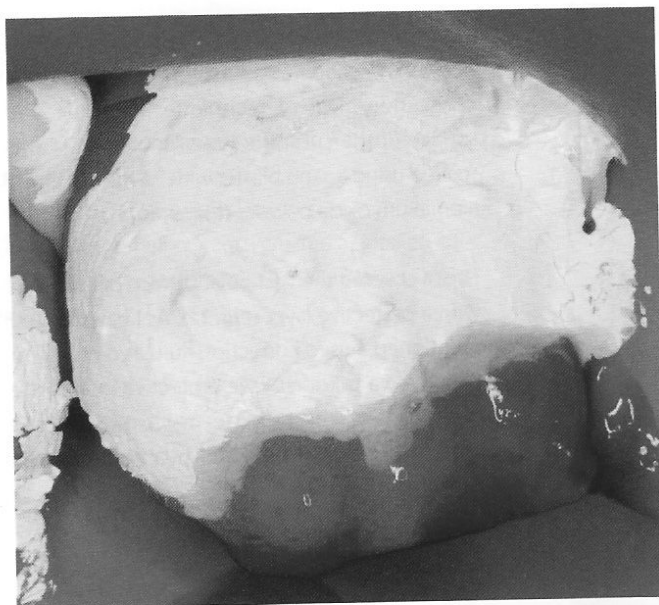
13
Enamel conditioning is strictly limited to the area free from protective layer

Afterwards, I followed standard adhesion procedure for the fifth generation system. Enamel conditioning was strictly limited to the area not covered with the protective layer (**Fig. 13**).

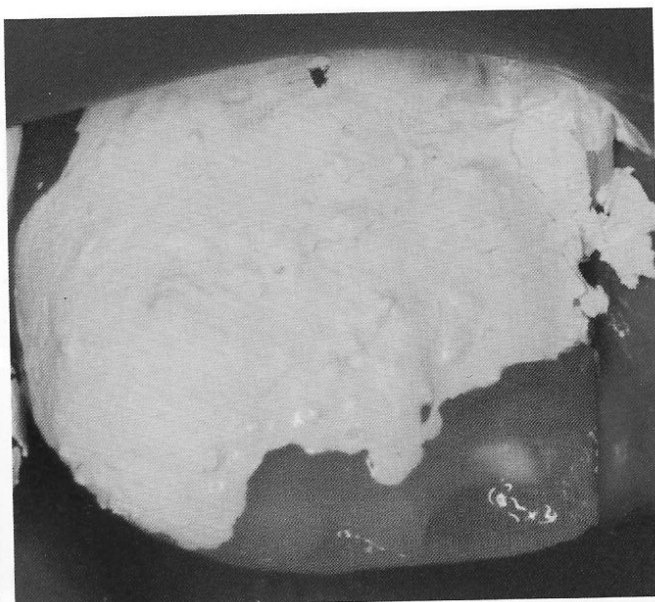
14
Construction of the palate wall

I started stratification with restoration of the palate wall by means of silicone keys and Enamel plus HRI UE1 mass (**Fig. 14**).

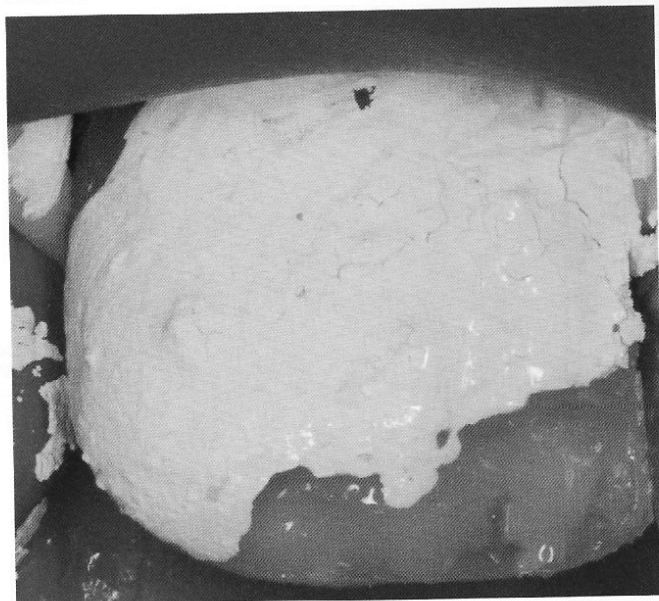
15
Construction of dentine body

Then I reconstructed dentine body using dentine UD4 and paints (**Fig. 15**) and finished the restoration by applying enamel mass (**Fig. 16, 17**).

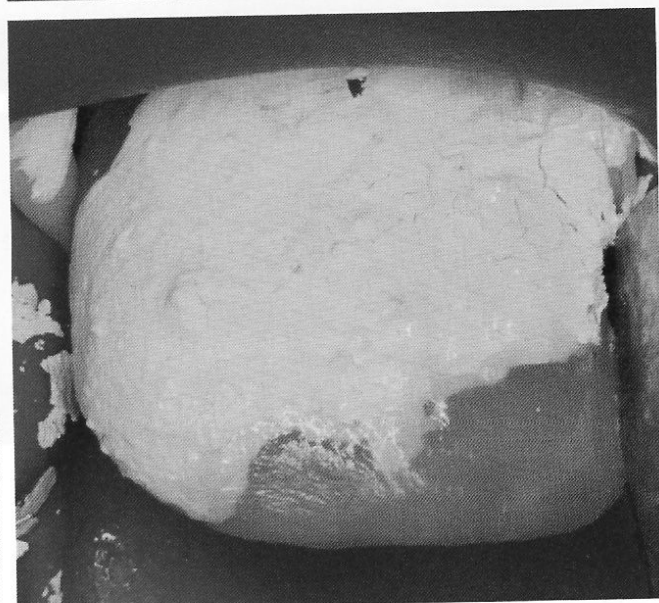
16
Stratification is finished

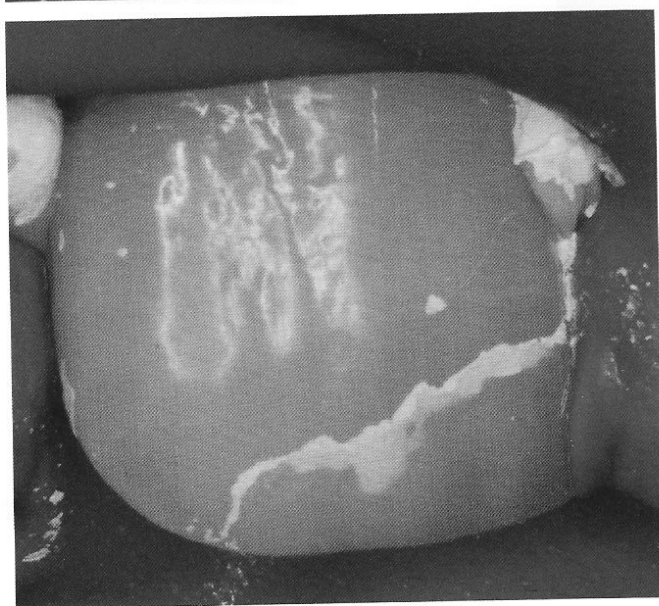
17
The protective layer is removed by means of air-flow

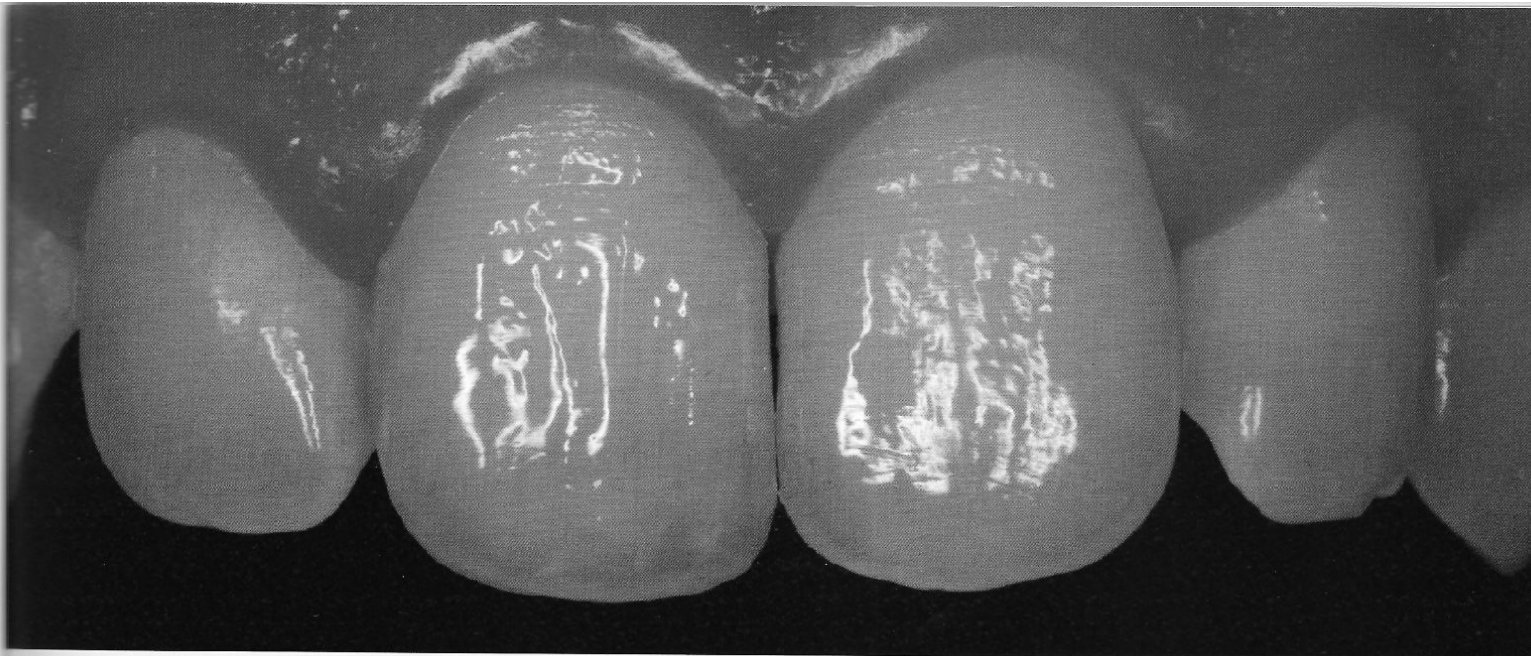
18
The restored tooth no. 11

Stratification was carried out using 3D tissue maps for guidance. Finishing was carried out in accordance with the procedure for Enamel plus Shiny (**Fig. 18**).

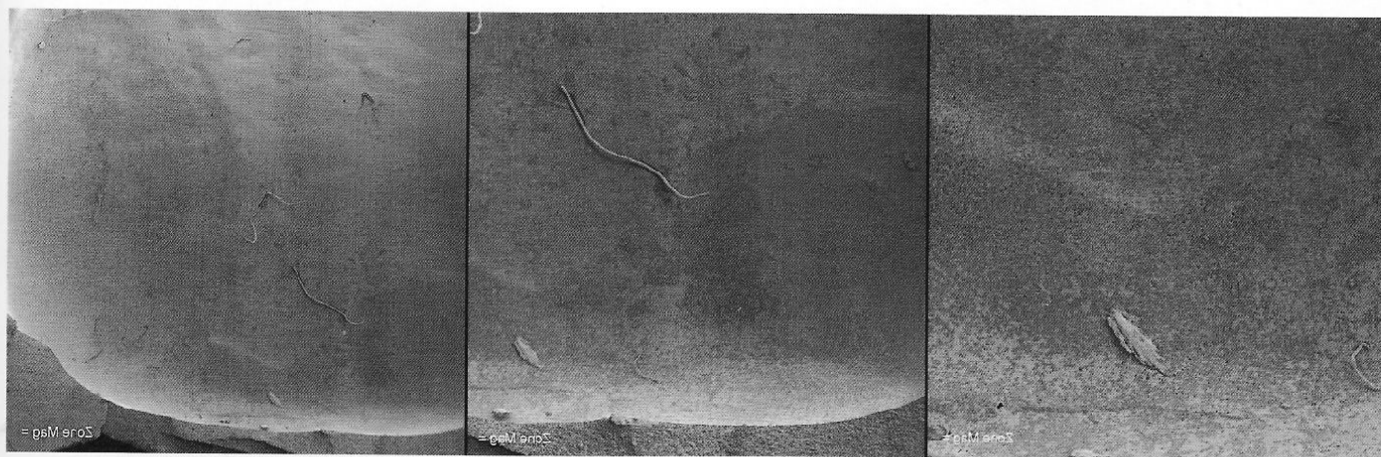
19-21
SEM of the final result

I took several SEMs with different magnifications to demonstrate how clean the surface can be when using a protective layer (**Fig. 19, 20, 21**). One can be absolutely sure that the enamel surface is free from excess composite material and adhesive system.
